Client: Sample Report
Subject Property: 123 Main Street
Anytown, MT
Date: March 23, 2007

Infrared Survey Report

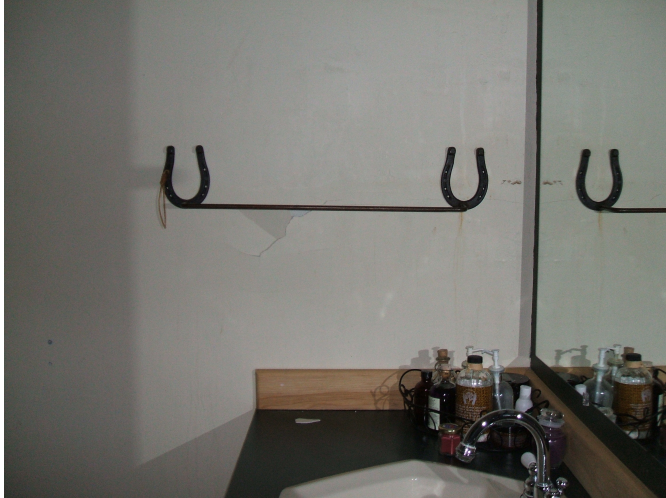
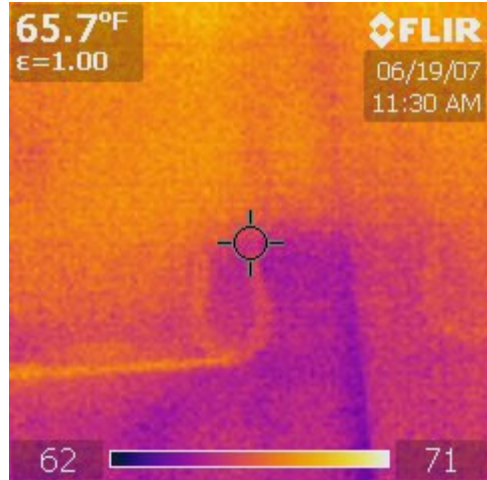
Downstairs Bathroom - Looking south at the towel bar

This area of the wall shows damage to the plaster behind and around the towel bar. The infrared image shows a cool area below and to the right of the towel bar suggesting moisture infiltration. The presence of moisture was confirmed with a moisture meter.

There was damage from suspected moisture infiltration in the downstairs bath, which could be seen both visually and on the infrared thermal image. The underlying cause for the suspected moisture damage is probably related to the negative grade on the west side of the home. Adding rain gutters and downspouts may mitigate the condition, but regarding the area may be needed.

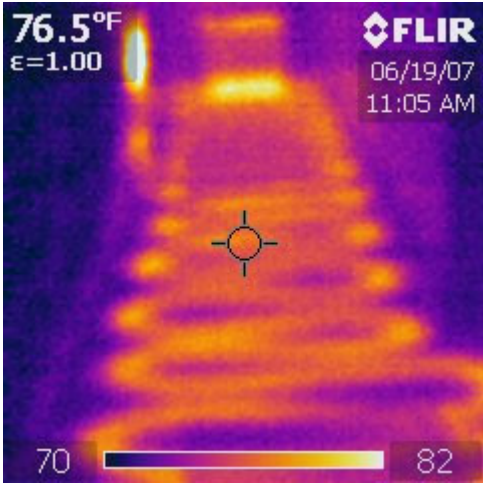
Image Location Main floor hallway - looking east.
	Description The infrared image shows the loops of the in floor radiant heat. It is typical of what was seen throughout the house.

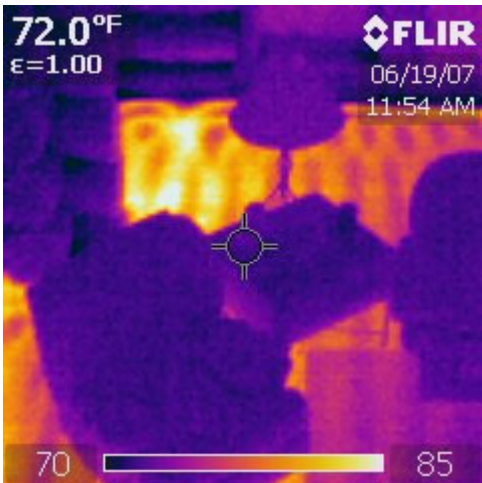
Image Location Living room - looking down from the upstairs hallway.
	Description The infrared image shows the loops of the in floor radiant heat. It is typical of what was seen throughout the house. The furnishings in the room show up in as colder (darker) areas.

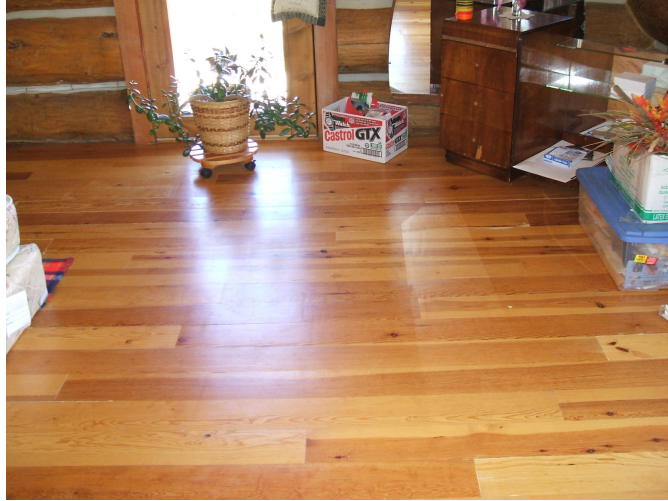
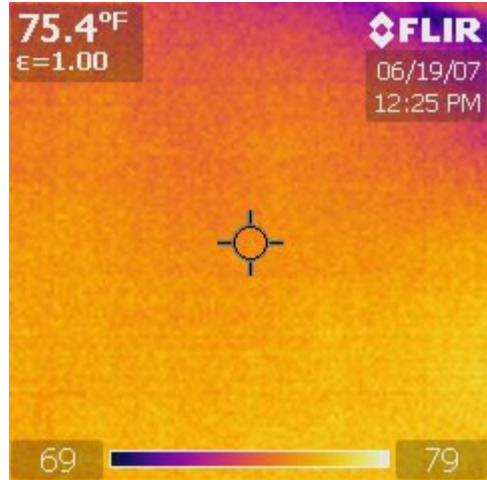
Master bedroom floor - looking north

The radiant floor heating in the bedroom appeared to be inoperative. This can be seen in the infrared image, which shows uniform temperatures (uniform color). This is in distinct contrast to the thermal images of the other floors in the house.

The in floor radiant heat appeared serviceable throughout the house with the noted exceptions of the master bedroom and the upstairs bedrooms and bath. A qualified heating contractor needs to evaluate the cause of the inoperative heating systems.

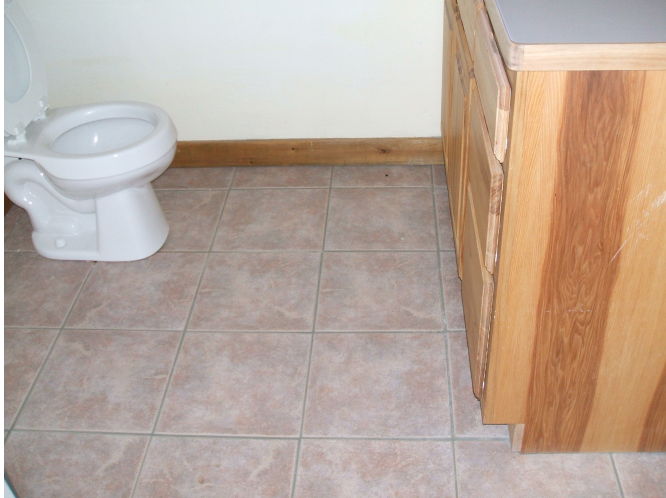
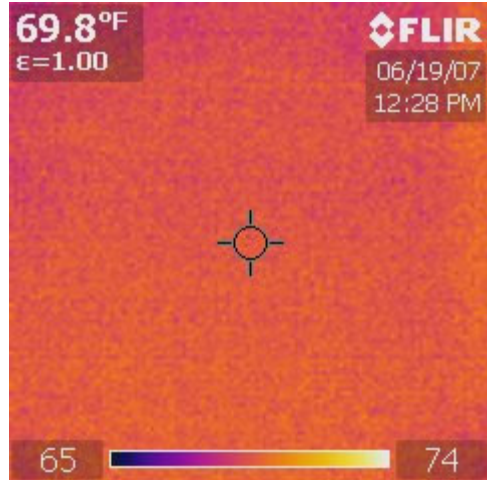
Upstairs bathroom - looking south.

The radiant floor heating in the upstairs bathroom appeared inoperative. This can be seen in the infrared image, which shows uniform temperatures (uniform color). This is in distinct contrast to the thermal images of the other floors in the house. Carpet has a tendency to obscure the thermal patterns seen with radiant heating, but since the other rooms in the upstairs were on the same circuit as the bath, it is likely the heating in these rooms was also inoperative during this inspection.

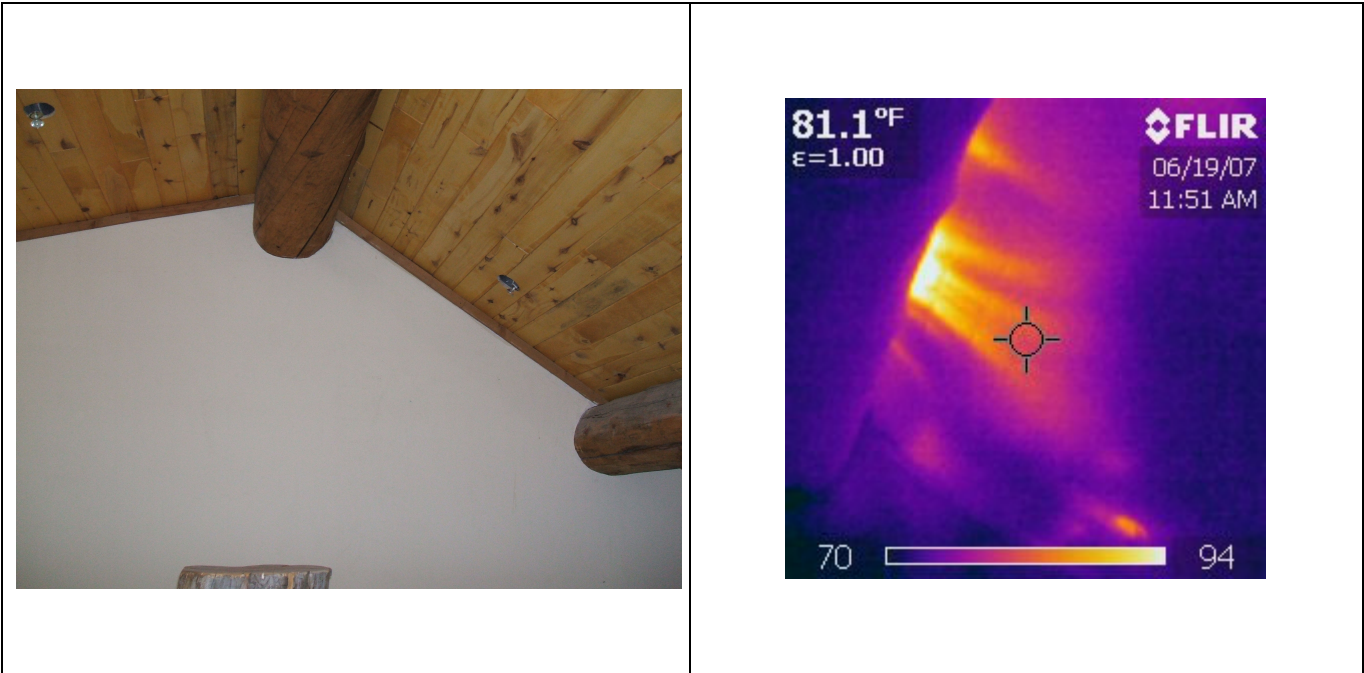
Image Location
 Living room west wall, ceiling intersection showing the main ridge beam. Taken from upstairs hallway.

Description
 The infrared image clearly shows air infiltration around the beam. Solar heating on the roof was such that the air infiltrating was warmer than the interior air at this time in the inspection. This warmer air shows up as yellow and white on the scale. The elongated fingers of different temperature are typical of what is seen with air infiltration as seen with a thermal imager. The kitchen and bathroom fans were used to evacuate the interior air creating negative pressure in the house. Exterior air will then infiltrate through cracks, poorly caulked seals, and areas of missing insulation.

There is considerable air infiltration around the main ridge beam in the living room. This area should be resealed to prevent air infiltration.

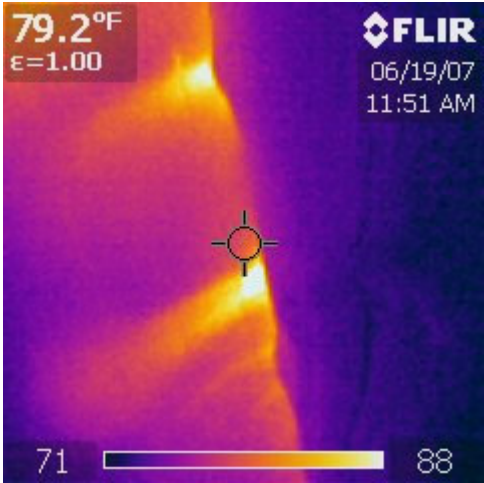
Image Location Main ridge beam - looking east.
	Description The infrared image clearly shows air infiltration around the beam. Solar heating on the roof was such that the air infiltrating was warmer than the interior air at this point in the inspection. This warmer air shows up as yellow and white on the scale. The elongated fingers of different temperature are typical of what is seen with air infiltration as seen with a thermal imager.

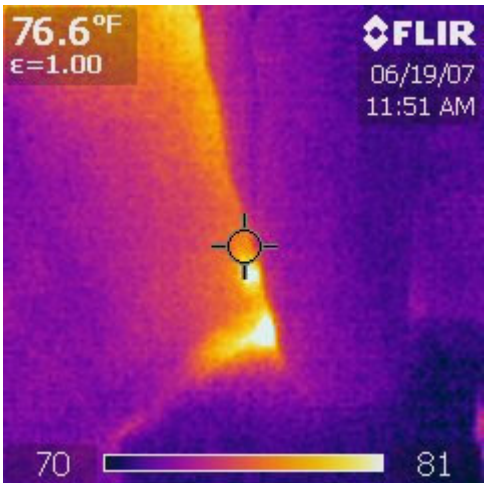
Image Location Ridge beam - rock fireplace intersection on the north side.
	Description The infrared image clearly shows air infiltration around the beam. Solar heating on the roof was such that the air infiltrating was warmer than the interior air at this point in the inspection. This warmer air shows up as yellow and white on the scale. The elongated fingers of different temperature are typical of what is seen with air infiltration as seen with a thermal imager.

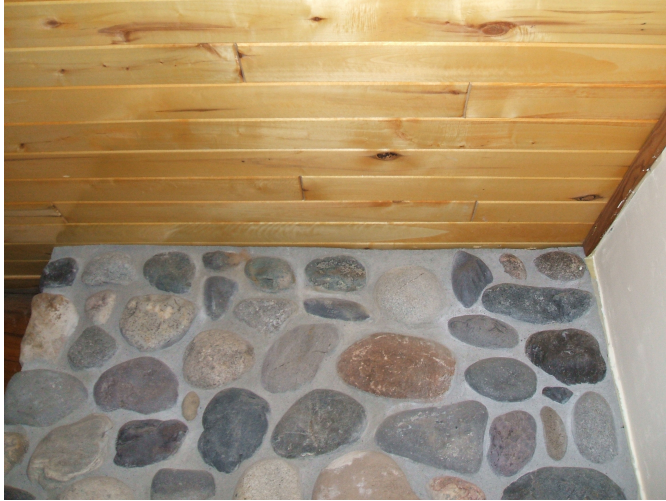
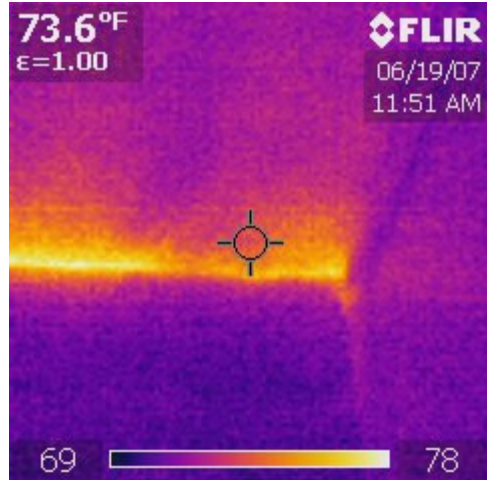
Ceiling chimney intersection - looking north from the upstairs hall.

The infrared image clearly shows air infiltration from behind the rock. Solar heating on the roof was such that the air infiltrating was warmer than the interior air at this point in the inspection. This warmer air infiltrating around the beam behind the rockwork shows up as yellow and white on the scale.
