ROOF VENTILATION RETROFIT

When flawed air and vapor barriers caused this roof to decay, a new venting system was the answer

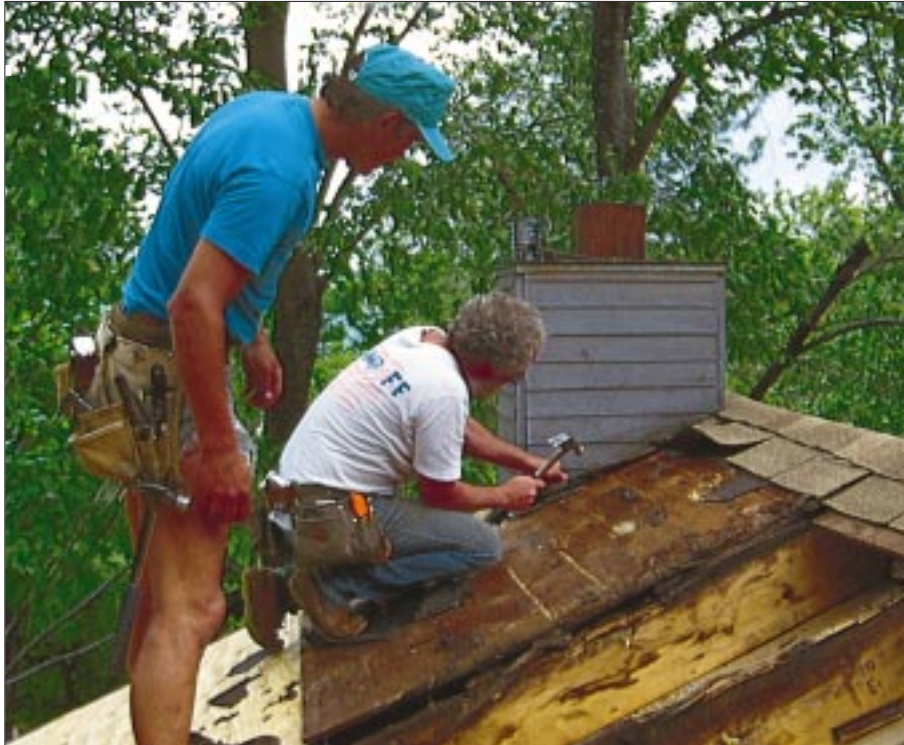
Workers tear off rotten sheathing over an unvented cathedral ceiling.

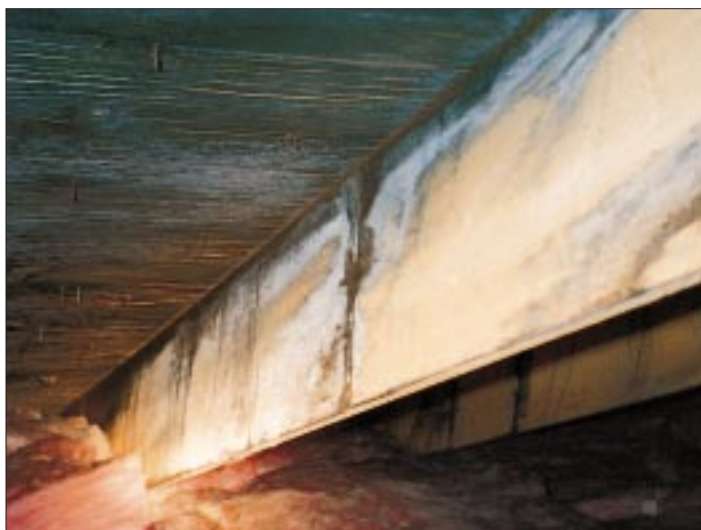
Telltale stains. I was first called to the site in 1987, one year after the house was built, to find the cause of water stains on the cathedral ceilings. One glance was all I needed to know that they were caused by condensation on the underside of the roof. To confirm my suspicions, I first looked in the attic. There were water stains on the sides of the rafters, and mold was growing on the plywood sheathing. The obvious cause of the moisture buildup was a lack of ventila-

Figure 1. Moisture trapped in the attic raised the moisture content of the wood to well over 20%. Vigorous growth of several types of fungi turned the underside of the roof sheathing completely black.

What I found in the attic was beyond belief. The attic rafters were stained far worse than I remembered. But when I looked at the discolored roof plywood, my first thought was that someone had sprayed the sheathing with matte black paint (see Figure 1). Later, in helping to prepare the owner's lawsuit, I scraped off some samples and sent them to two wood toxicologists to have them assessed. The tests confirmed what I already knew: The several types of fungi flourishing on the sheathing were precursors to decay-causing fungi, and required over 20% moisture content in the wood to grow.

The obvious answer to the attic problem was to provide needed ventilation by installing continuous ridge and soffit vents. Adding ventilation to the cathedral roofs, however, would be difficult and expensive, because I assumed that there was not enough uninterrupted space for air circulation above the insulation. That would mean opening up the whole roof, because the rafters over the living room were well over 20 feet long. So I offered an alternative solution of sealing drywall cracks from the inside and painting with low-perm paint.

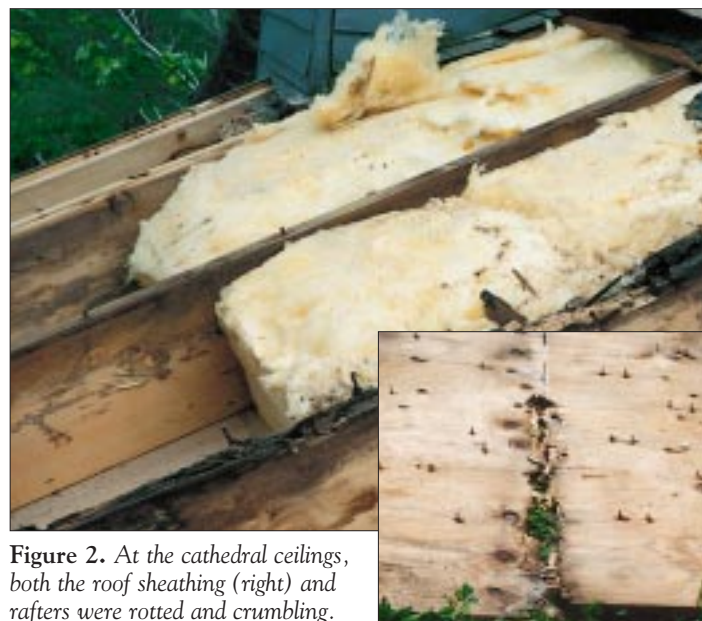
Figure 2. At the cathedral ceilings, both the roof sheathing (right) and rafters were rotted and crumbling.

The plywood, once exposed, was discolored and deteriorated, and was also quite soft. When the last of the nails was removed and the carpenter lifted the piece of plywood up on edge, it was so rotten, it literally sank into the rafters by a couple of inches (Figure 2). The underside was soaking wet and blotchy — black in places and white in others — from a variety of molds. The top 2 inches of the exposed rafters were also rotten. A second later, hundreds of carpenter ants rushed up out of the framing and scattered across the damp insulation.

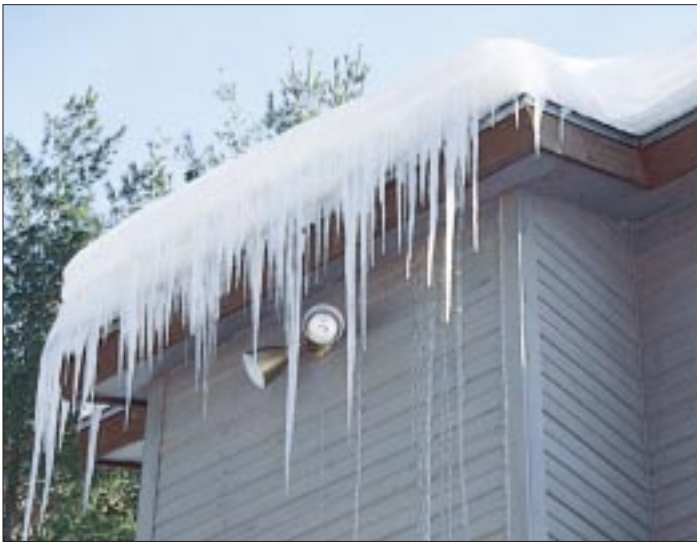
That winter, thick ice dams built up at the eaves (Figure 3). Water backed up into the structure, and ran down the outside wall and back along the cantilevered floor joists, finally exiting and freezing between clapboards on the first-floor wall. Water also ran steadily onto the floor of both upstairs bedrooms, soaking the carpet at least 4 feet into the room. When I went to look at the damage, I found the carpet pulled back and

Figure 3. The winter before repairs were made, huge ice dams formed at the eaves of this cathedral roof. Water backed up into the soffits and walls, soaking interior and exterior finish materials.

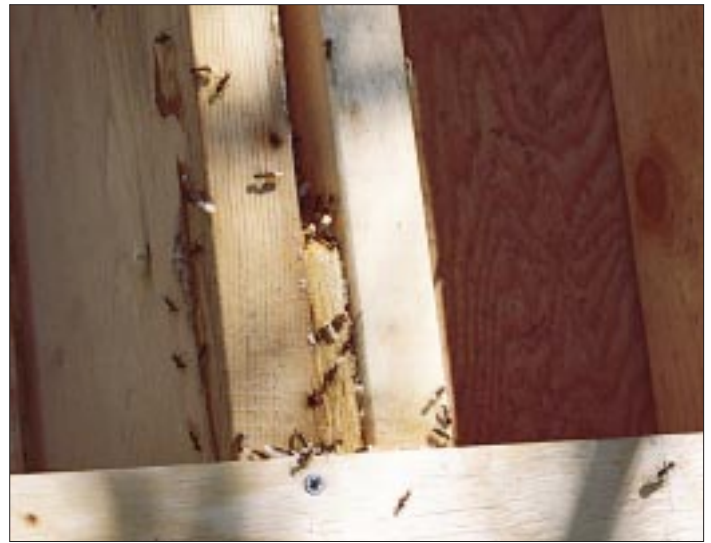
Figure 4. High moisture in the cathedral roofs created a perfect environment for carpenter ants, which tunneled into the insulation and nested in cracks between framing members.

At the cathedral ceilings, most of the moisture damage was confined to within 8 feet of the ridge. Much of the plywood sheathing was so badly rotted that it broke into pieces while the nails were being removed and again when it was lifted off the rafters. Hundreds of carpenter ants had nested in cracks and seams between framing members, and had tunneled into the fiberglass insulation (Figure 4).

The top 2 inches of the rafters were also rotten; by contrast, the bottoms and lower two-thirds of the rafters' length were water-stained, but still sound. All of the fiberglass insulation was removed as a precaution against any remaining ant infestation. Before any new framing material was installed, the rotten parts

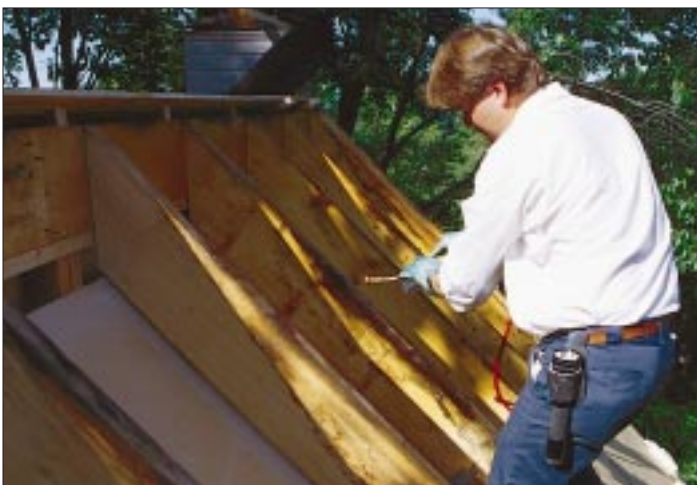
Figure 5. Before installing sister rafters and insulation, the existing framing was sprayed with a fungicide and insecticide.

of the rafters were removed, and the entire area was treated with a fungicide and insecticide (Figure 5).

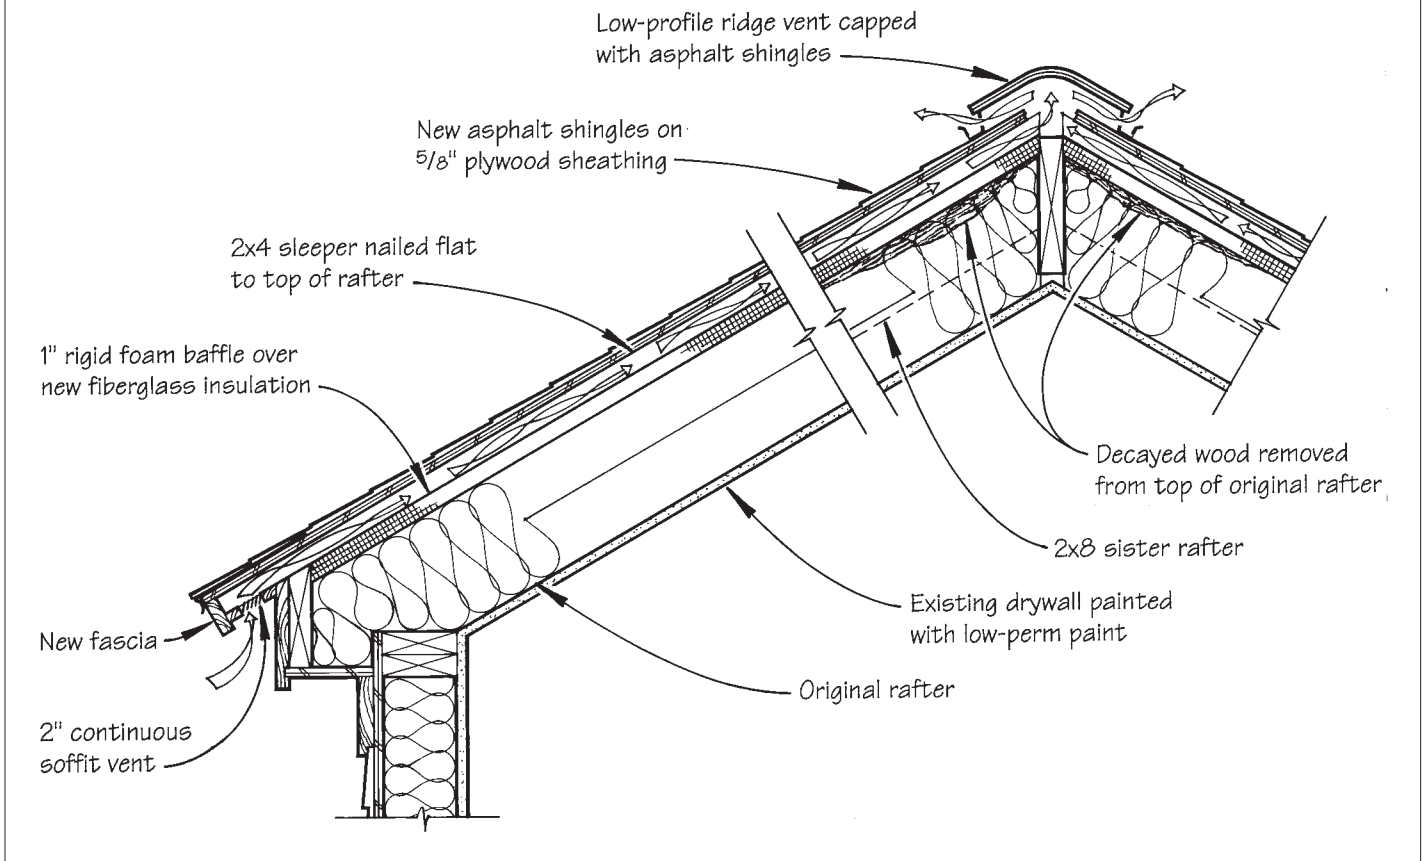
Figure 6. A cold roof is designed to maintain a minimum 1½-inch air space between the insulation and the roof sheathing. Continuous soffit and ridge vents carry away moisture-laden air, preventing condensation in the rafter bays.

Cold roof. The cold roof design I specified is one I have used extensively in northern Vermont for nearly 20 years with great success (Figure 6). It has two purposes: to prevent — or at least to reduce — snow melt and the resulting ice dams by keeping the underside of the sheathing cold; and to give any moisture-laden warm air an escape route through the air space and out the ridge vent.

To reinforce the rafters and to provide for a continuous air space below the new sheathing, 2x8 sister rafters were set 1½ inches above the top of the existing roof plane. On the sound wood of the lower roof section, 2x4 sleepers were centered and fastened flat to the top of the rafters to establish the new roof plane and maintain a continuous air space. The builder believed it was too difficult to do a good job of installing a poly vapor barrier in the bays from above. Instead, he taped the drywall joints with duct tape to prevent convection, then carefully installed new R-30 Kraft-faced insulation. The ceilings would be repainted with low-perm paint.

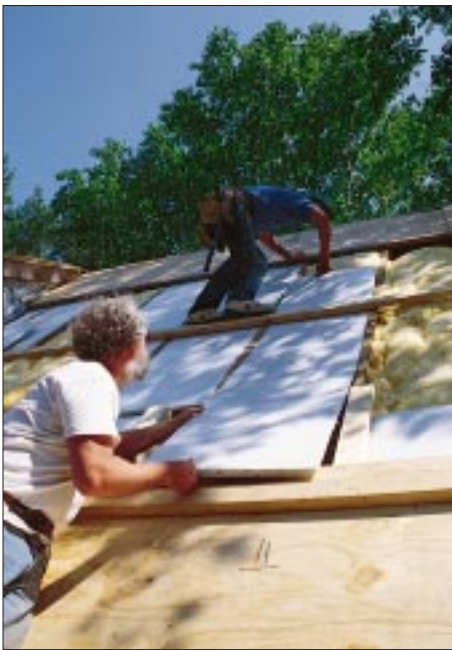
Figure 7. Two-by-four sleepers on top of existing rafters provide a ventilation chute beneath the plywood sheathing, while 1-inch rigid foam insulation prevents the fiberglass batts from expanding into the air space.

We opted for 1-inch-thick extruded polystyrene rigid foam insulation to keep the batts from expanding into the newly created air space. The rigid foam also added an additional R-5 to the roof, and its smooth surface provided less resistance to airflow than the fiberglass insulation. In the sistered area, the foam was held in place with a few nails tacked into

the side of the rafters (Figure 7); in the area of the 2x4 sleepers, the overhang on each side of the rafter held the foam in place.
