ROOF VENTILATION RETROFIT

by Henri de Marne

When flawed air and vapor barriers caused this roof to decay, a new venting system was the answer

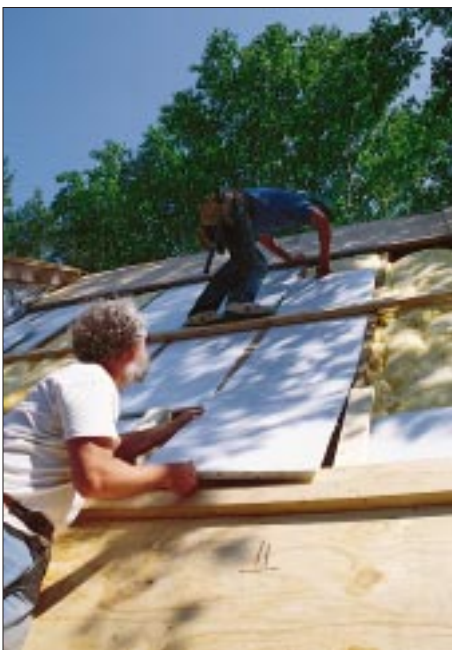
Figure 7. Two-by-four sleepers on top of existing rafters provide a ventilation chute beneath the plywood sheathing, while 1-inch rigid foam insulation prevents the fiberglass batts from expanding into the air space.

We opted for 1-inch-thick extruded polystyrene rigid foam insulation to keep the batts from expanding into the newly created air space. The rigid foam also added an additional R-5 to the roof, and its smooth surface provided less resistance to airflow than the fiberglass insulation. In the sistered area, the foam was held in place with a few nails tacked into

the side of the rafters (Figure 7); in the area of the 2x4 sleepers, the overhang on each side of the rafter held the foam in place.
